Manhole Inspection Summary

Manhole # S04II2016MH

Insp Date: **7/19/06 8:11 AM**

Location Address: **3219 SHELBURNE RD**

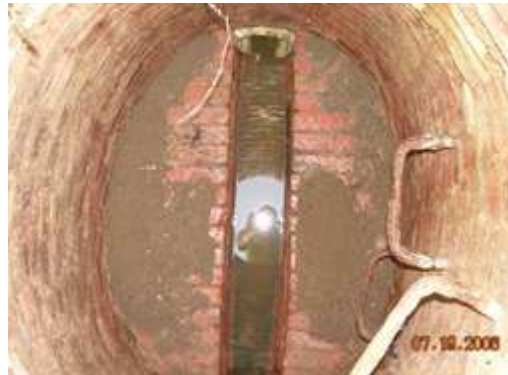
Top View

Adjustment and Corbel infiltration.
Corroded steps. Evidence of surcharge -
Bench debris.

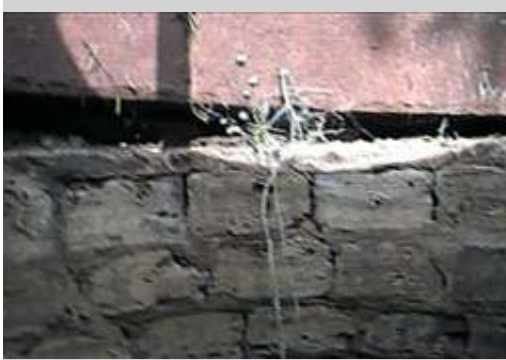
Defect

Condition: ☐ Sound ☐ Cracked ☒ Root Intrusion ☒ Loose Brick ☒ Deteriorated

Infiltration: ☐ None ☒ Joint ☐ Cracks ☒ Mortar ☒ Roots ☐ Wall

Adjustment deterioration, loose brick, root
intrusion and infiltration.

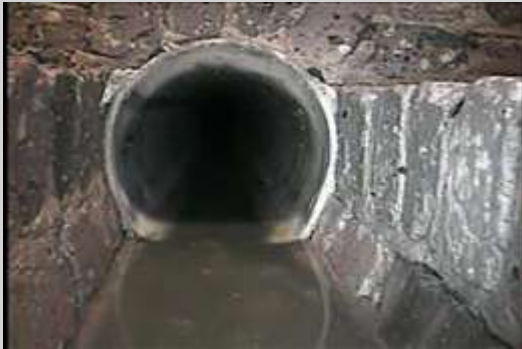
8 in. Circular Gravity Sewer Pipe Out @ 12 O'Clock

Condition: ☐ Sound ☐ Cracked ☐ Root Intrusion ☒ Deteriorated ☐ Leaks ☐ Debris

Channel deterioration.

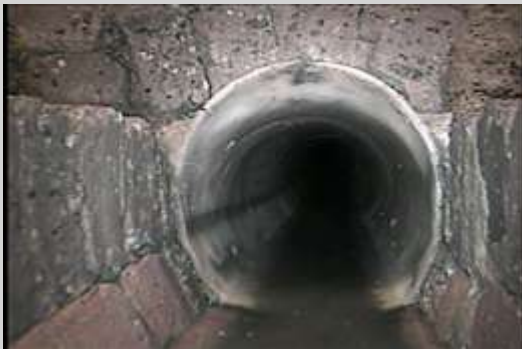
8 in. Circular Gravity Sewer Pipe In @ 6 O'Clock

Infiltration: ☐ None ☐ Joint ☐ Cracks ☒ Mortar ☐ Roots ☐ Wall

Barrel infiltration.
